Service Publication for the Kodak Ektachem DTSC MODULE

Kodak Ektachem DTSC MODULE General Information Section 1

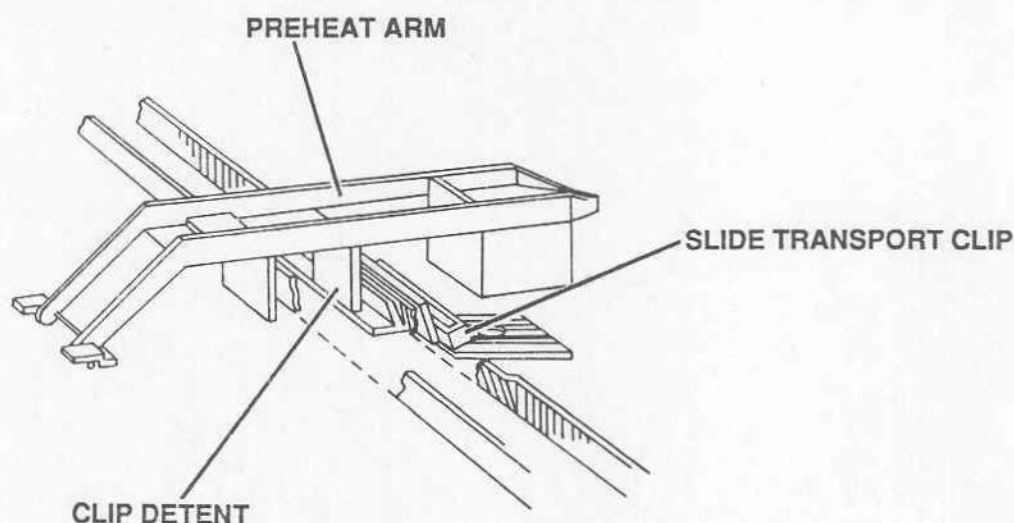
20. The DTSC MODULE is now ready to receive another slide at the Pickup Station. If the operator inserts an additional slide, the CONTROLLER BOARD will monitor the motions of the CLIP to move each slide to the correct station at the correct time. If the CLIP must move through the Preheat Station or the Read Station when the ARMS are down, the CLIP DETENTS on the ARMS cause the CLIP to be bent back on the flexible BELT, so that the CLIP will not engage any slides under the ARMS.

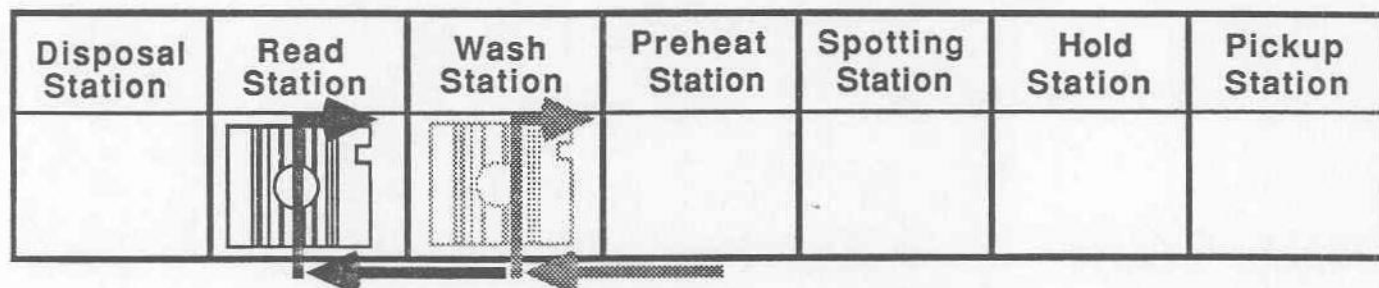
25. The FLASH LAMP energizes to take a reading of the WHITE REFERENCE on the bottom of the READ ARM. This reading will be used for a white reference reading during the read cycle.

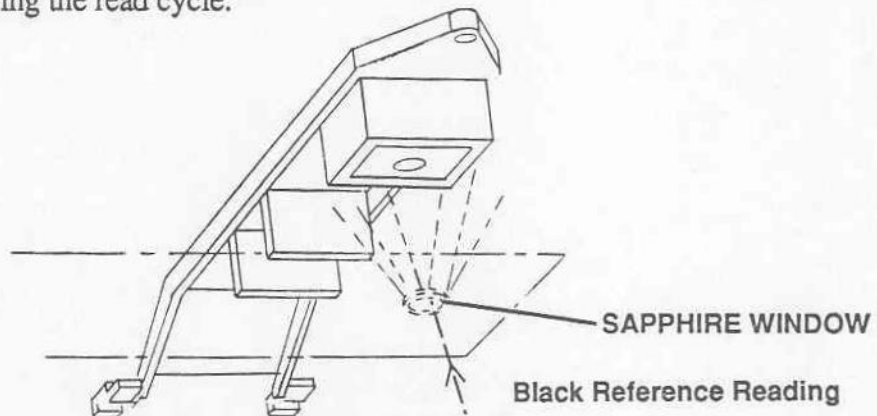
26. The SLIDER CAM does not stop at home•position, but continues to move to the left, lifting the READ ARM. The HALL EFFECT SENSOR detects that the READ ARM is up.
27. When the READ ARM is up, the FLASH LAMP energizes again. Because no surface reflects the light down through the SAPPHIRE WINDOW, this reading will be used for a black reference reading during the read cycle.

28. The slide advances a short distance beyond the Read Station, and then the direction of the BELT reverses, causing the slide to move backward against the STAGING RAMP. This motion moves the slide directly above the SAPPHIRE WINDOW.
29. The SLIDER CAM moves to home•position. The READ ARM moves down over the slide.

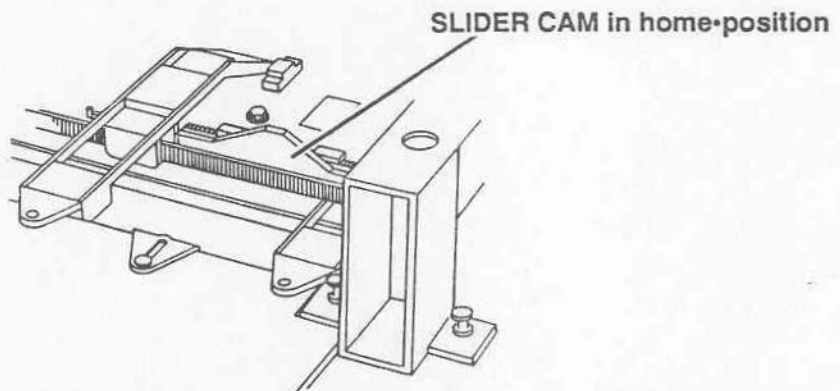
30. The HALL EFFECT SENSOR detects that the slide is under the READ ARM. If no slide is in the Read Station, error code F31 occurs.
31. The data for the number of readings was sent from the CLM when the the BAR CODE was identified. The FLASH POWER SUPPLY energizes the FLASH LAMP for the necessary number of readings.
32. When the reading cycle is completed, the results are printed.
33. The SLIDER CAM moves left, lifting the READ ARM. The CLIP engages the slide. The HALL EFFECT SENSOR detects that the READ ARM is up.
34. The CLIP moves the slide to the Disposal Station, and the slide falls into the DISPOSAL CUP. The CLIP is now in the home•position.
35. At the same time, the SLIDER CAM moves right, to the home•position. The READ ARM moves down.

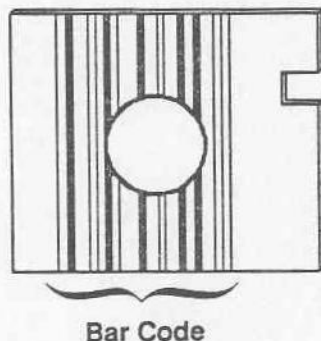
The BAR CODE READER has a Light Emitting Diode that emits a beam of light, and a Photo Diode that receives the light reflected from the slide. The beam is projected through a hole in the TRACK, which allows no light to be reflected up to the BAR CODE READER until a slide is inserted. As the slide moves under the BAR CODE READER, the bar code is read.

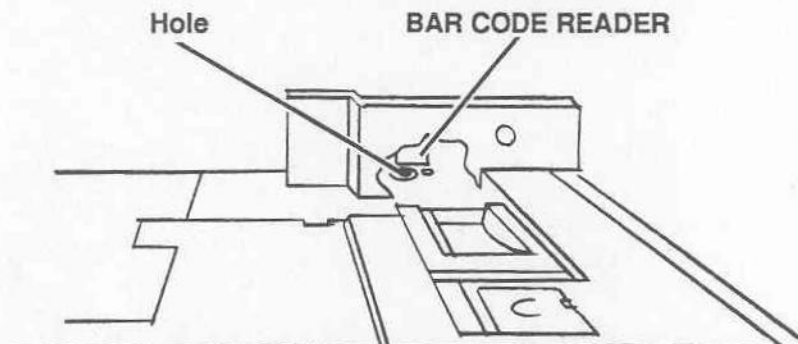
**BAR CODE READER BOARD**

The BAR CODE READER BOARD monitors the data input functions for the Slide Identification System. POTENTIOMETER R1 is adjusted to emit a specified voltage for the maximum white reflectance obtained from a slide. The CONNECTOR J7 connects the BAR CODE READER BOARD to the ANALOG BOARD for data communication.

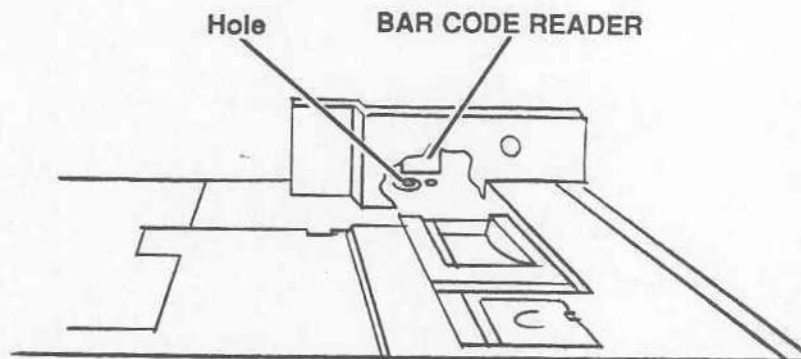
1. When the *DTSC* MODULE is initialized, the BAR CODE READER projects a light to a hole in the TRACK. The hole allows almost no light to be reflected up to the BAR CODE READER.

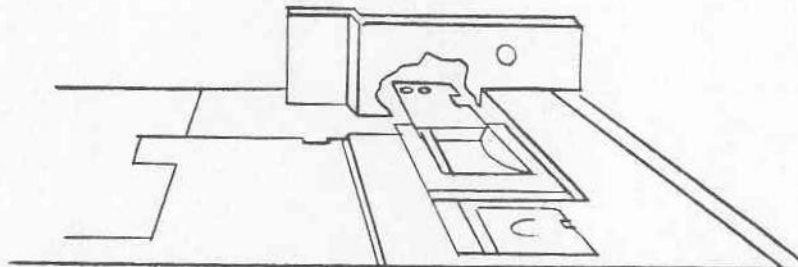
2. The white surface of an inserted slide reflects light to the BAR CODE READER, which causes a signal to the ANALOG BOARD. The ANALOG BOARD sends a message to the CONTROLLER BOARD. This signal begins the operation sequence.

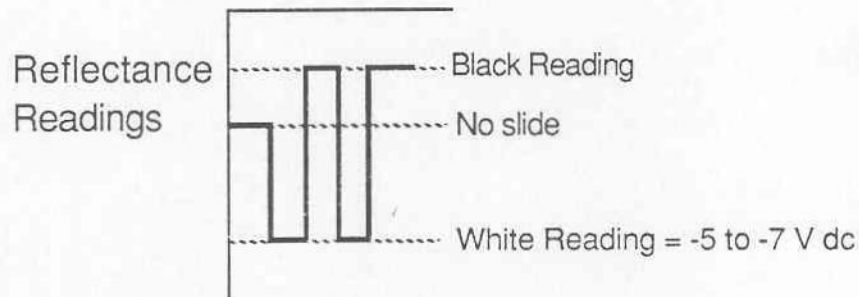
Voltage signal for bar code:

7. The BAR CODE READER BOARD makes a series of electrical signals that correspond to the light reflected from the white and black lines in the bar code. The white lines reflect light, and the black lines do not. The adjustment procedure for the BAR CODE READER gives a uniform negative electrical value to the white lines. The length of the signals correspond to the thickness of the lines.

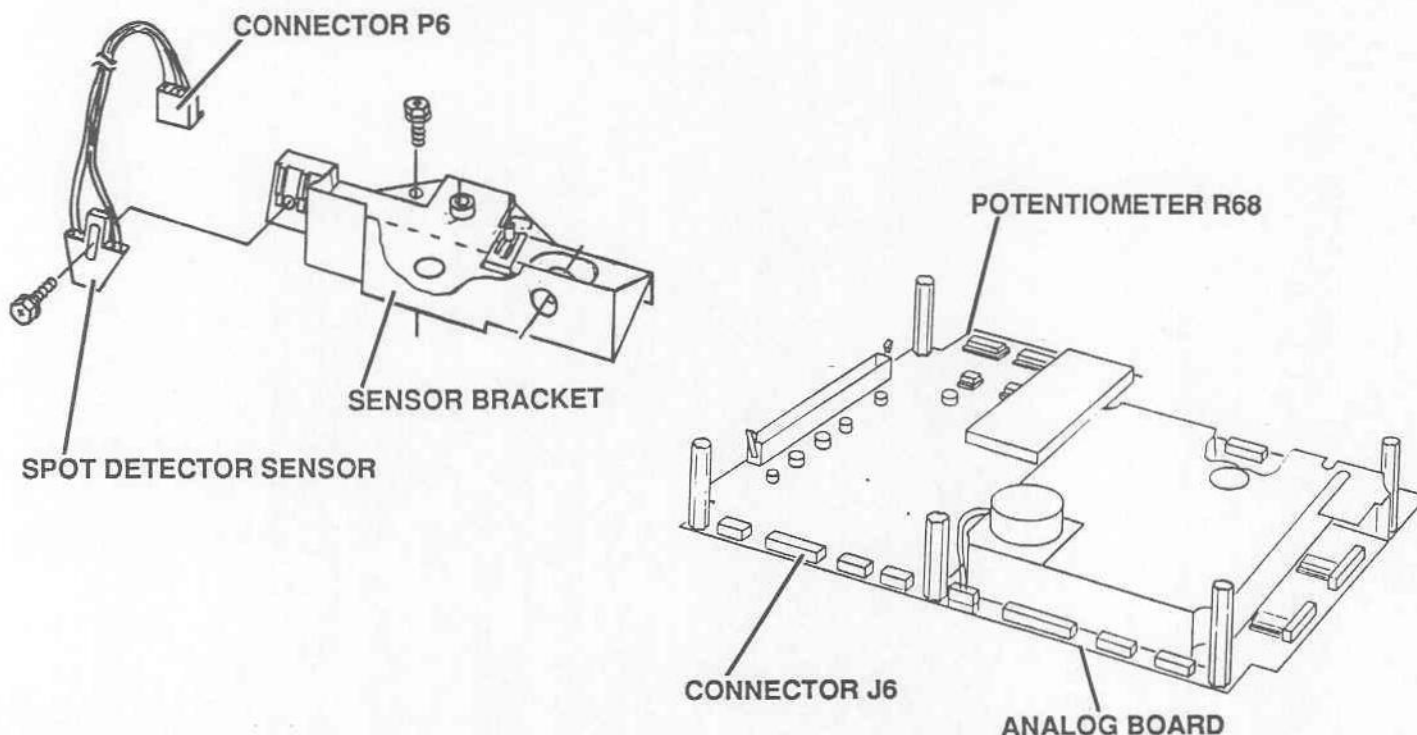
The function of the SPOT DETECTOR SENSOR is to detect the change of reflectance caused when a drop of fluid is dispensed on a slide. The SPOT DETECTOR SENSOR then executes a signal to continue the processing cycle of the slide. The SPOT DETECTOR SENSOR is energized continually, but the reading from the SPOT DETECTOR SENSOR is taken only when the slide is in the Spotting Station and ready to be spotted.

POTENTIOMETER R68 on the ANALOG BOARD adjusts the light output of the SPOT DETECTOR SENSOR.

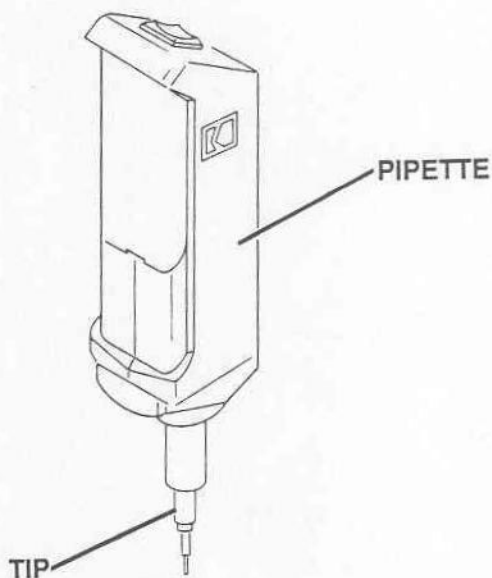
A PIPETTE with disposable TIPS is used to aspirate and dispense fluids. The PIPETTE used with the DTSC MODULE is the same PIPETTE provided in Modification No. 2 for the DT60 ANALYZER. The Operator's Manual, and the videotape "Kodak Ektachem DT and DTE PIPETTE" have more information about the function and correct operation of PIPETTES.

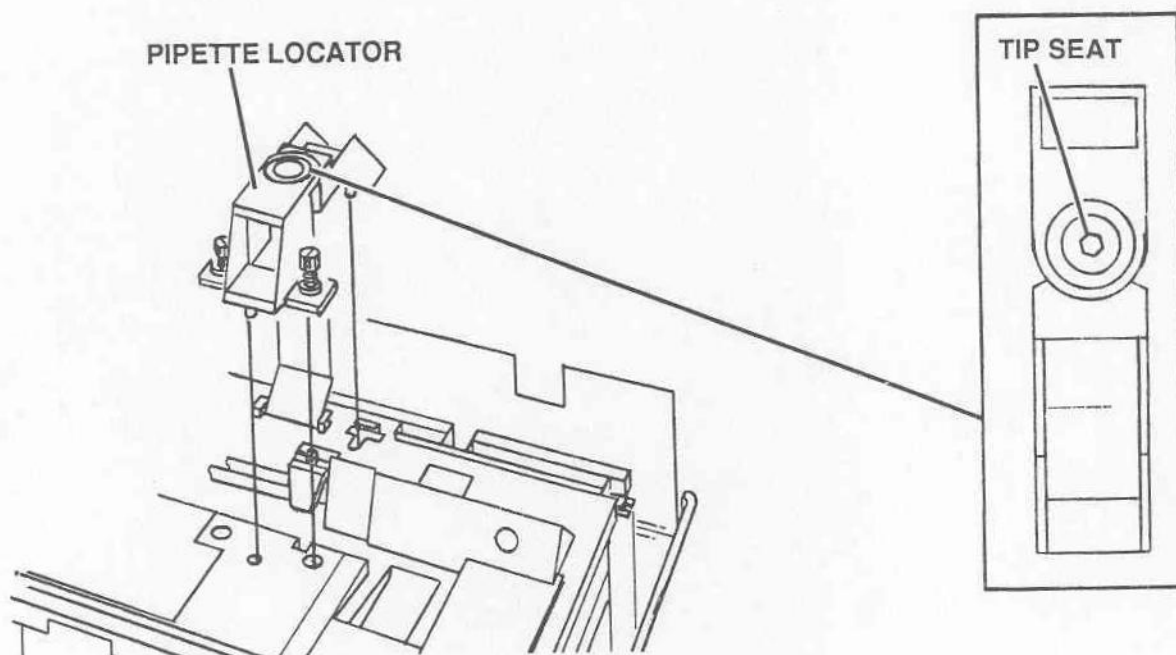
The PIPETTE LOCATOR holds the inserted PIPETTE in the correct position so fluid can be dispensed with precision. The TIP SEAT in the PIPETTE LOCATOR must be adjusted correctly to dispense the 10 mL drop of fluid in the correct position on the slide.

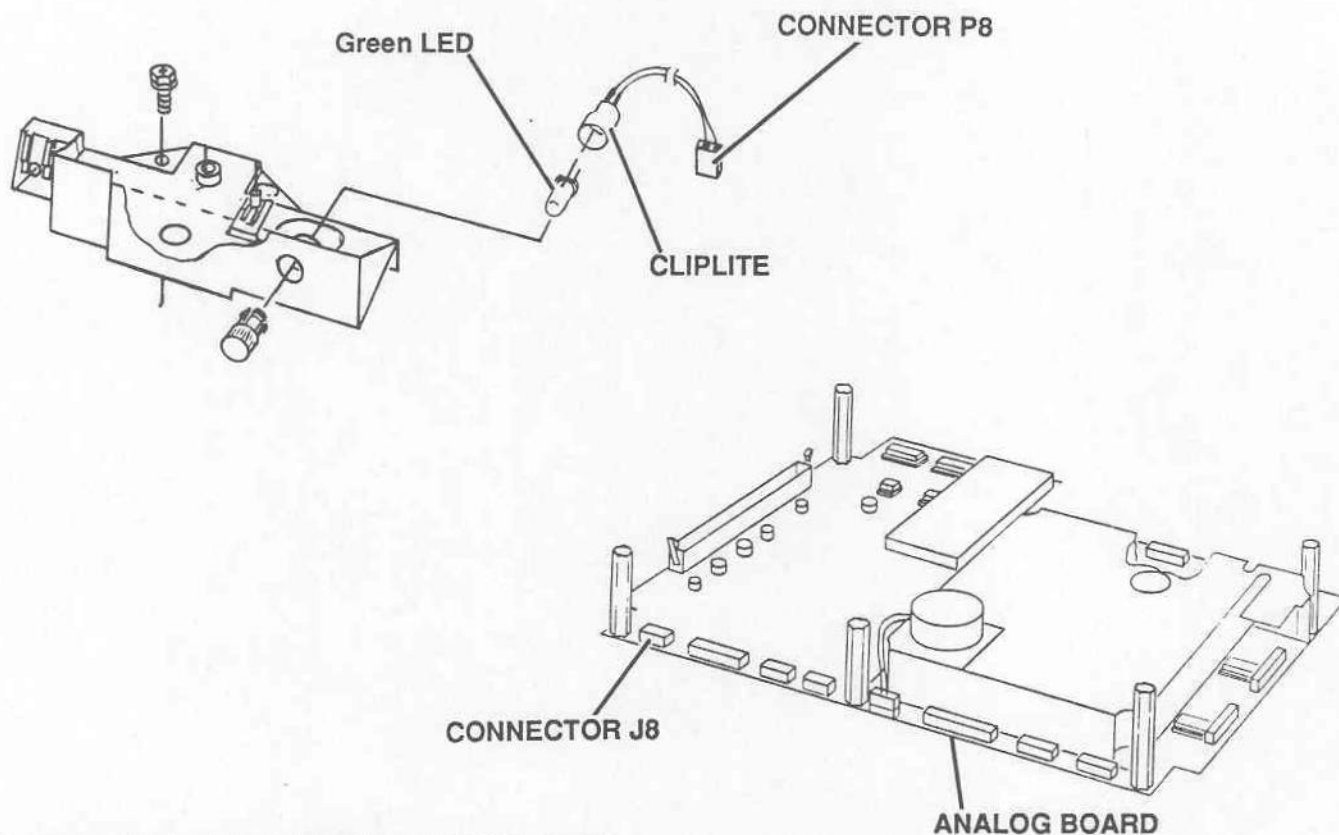
Green LED

The green LED blinks to indicate to the operator when the slide is ready to receive the fluid from the PIPETTE. The CLIPLITE hold the LED. CONNECTOR P8 provides data communication to CONNECTOR J8 on the ANALOG BOARD to the LED.

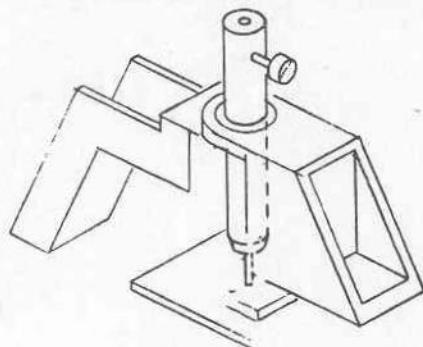
The TIP HEIGHT ADJUSTMENT GAUGE TL-3446 is used to check the distance from the slide to the TIP. If the distance is too short, the TIP could damage the slide, or the drop could adhere to the side of the TIP and not be dispensed on the slide. If the distance is too long, the drop might not be dispensed on the center of the slide. This tool is also used with the *DT60 ANALYZER*. The adjustment procedure has more information about using this tool.

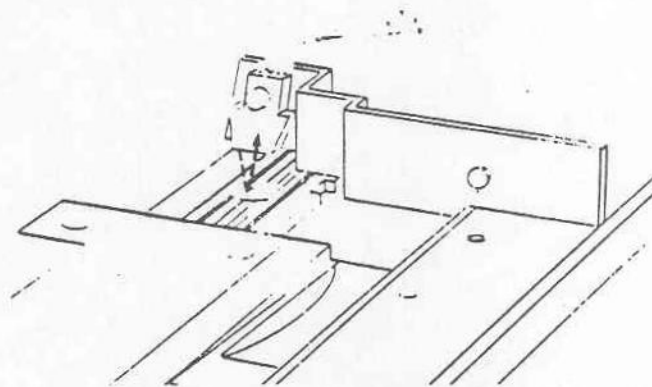
No drop. Normal light reflectance

4. The green LED blinks and a tone occurs to indicate to the operator that the slide is ready to be spotted.
5. When the drop is dispensed, the reduced reflection to SPOT DETECTOR causes a signal to the ANALOG BOARD. The slide is ready to advance to the Wash Station.

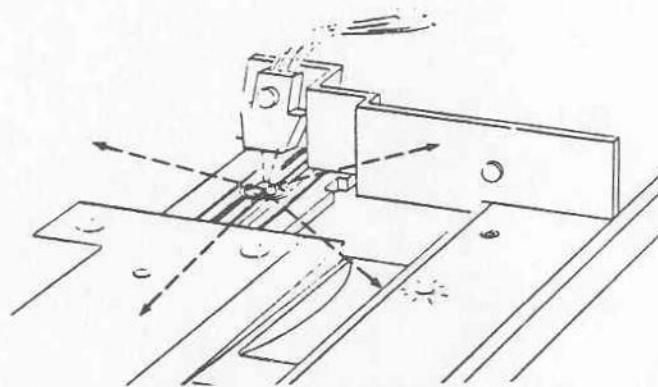
Drop on slide. Reduced light reflectance.

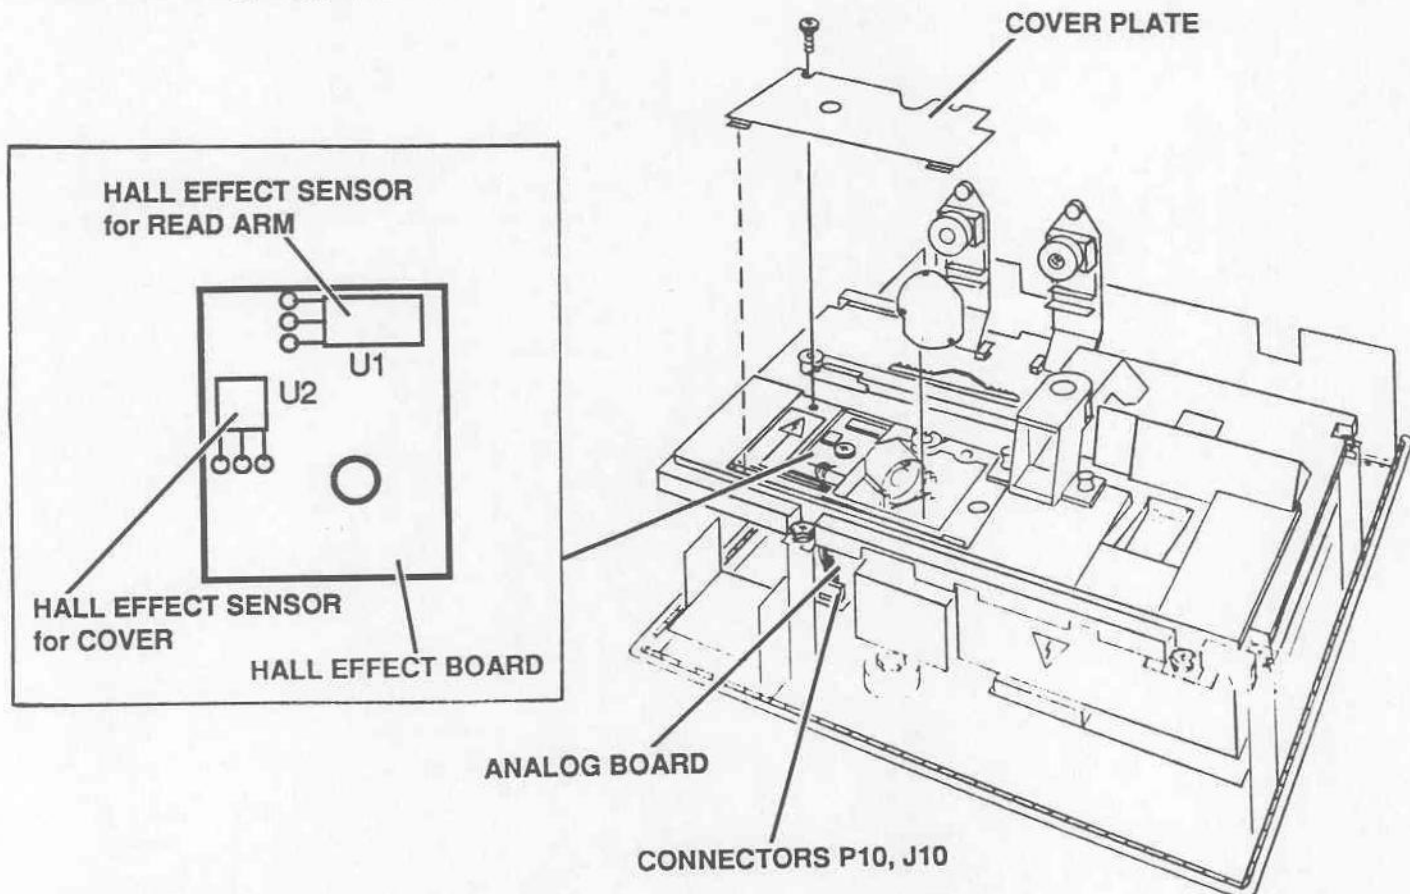
The HALL EFFECT BOARD monitors the signals of the HALL EFFECT SENSORS and transfers the signals to the ANALOG BOARD. CONNECTOR P10 provides data communication to CONNECTOR J10 on the ANALOG BOARD. The COVER PLATE must be removed for access to the HALL EFFECT BOARD.

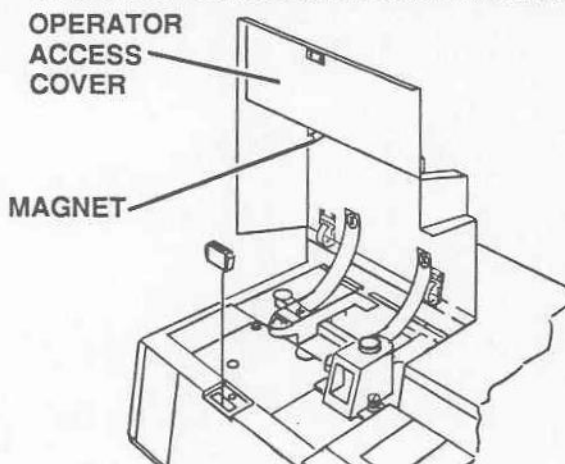
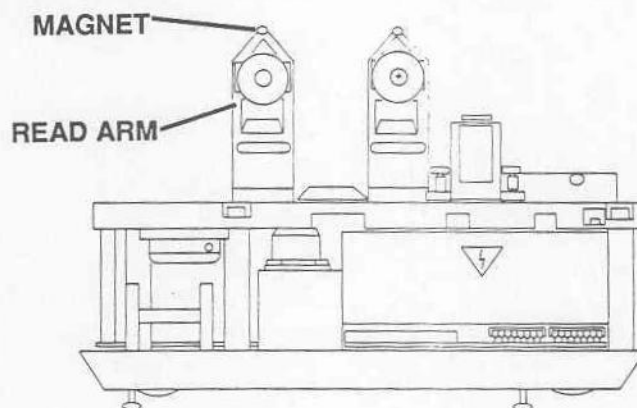
2 permanent MAGNETS are used with the HALL EFFECT SENSORS. One MAGNET is in the OPERATOR ACCESS COVER. The other MAGNET is in the end of the READ ARM. For correct operation, the correct poles of the MAGNETS must be toward the HALL EFFECT SENSORS. If a MAGNET falls out of the component, do not install it if you cannot determine the original position. Install a new READ ARM or a new OPERATOR ACCESS COVER for replacement parts.

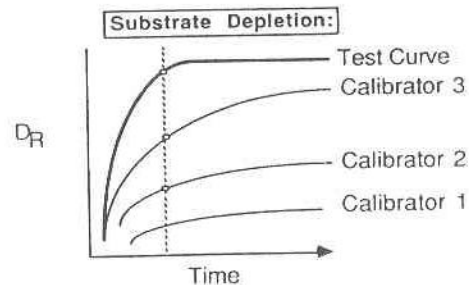
The following figure gives an example of Substrate Depletion. The first reading of the Test Curve has a value higher than the corresponding value of the Calibrator 3 curve. The rate of change is less than the rate for the Calibrator 2 curve. When this type of test result occurs, error code L11 and the message "RESULTS INVALID" are displayed, and no test results are given.

Error code L11 indicates that a "Substrate Depletion" condition is detected. Substrate Depletion errors indicate that the change in the rate chemistry for the test occurred too fast. The readings from the slide indicate that the density of the slide was at the maximum value when the first readings were made. This condition could be caused because the sample on the slide had a large concentration of analyte.

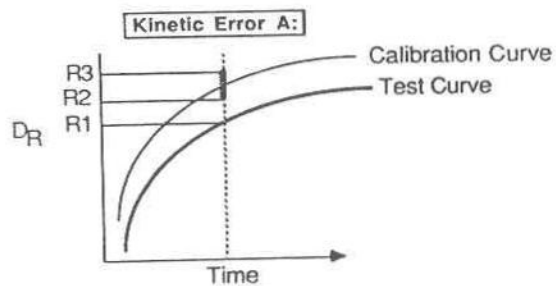
The following figure gives an example of Kinetic Error A. The test curve has the same slope as the calibration curve. The program requirement is that the first reading for any test curve with this slope should be within the limits R2 and R3. But the first reading of the test curve occurs at R1. Kinetic Error A has occurred, and error code L12 is displayed.

Kinetic Error A could occur because the sample fluid is contaminated with materials that cause the density of the slide to be increases or decreased.

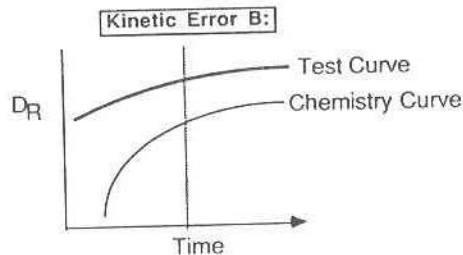
The following figure gives an example of Kinetic Error B. The last part of test curve has a slope that corresponds to the chemistry curve. The first part of the test curve has a slope that does not correspond to the chemistry curve.

This error condition is defined as "Kinetic Error B". Kinetic Error B could occur because the concentration of analyte is too high. Kinetic Error B could also occur because the sample fluid is contaminated, or if the patient has multiple myeloma, a pathology.

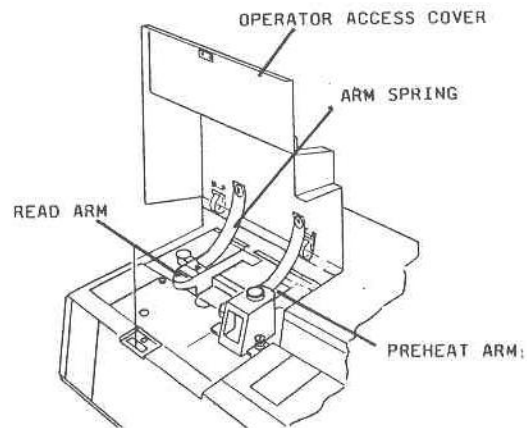
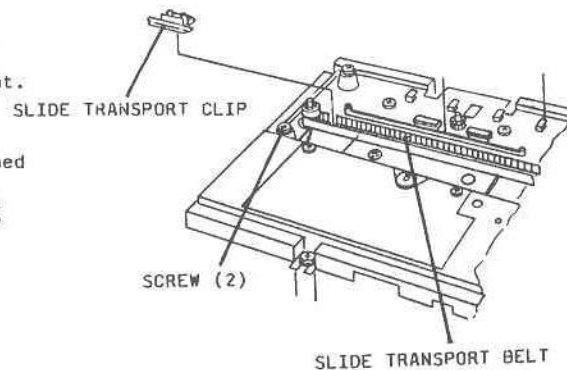
[6] Check that the SLIDE TRANSPORT CLIP is attached correctly to the SLIDE TRANSPORT BELT. Connect the SLIDE TRANSPORT CLIP if necessary.

[7] Check that the SLIDE TRANSPORT BELT is engaged correctly by the MOTOR PULLEY and the IDLER PULLEY.

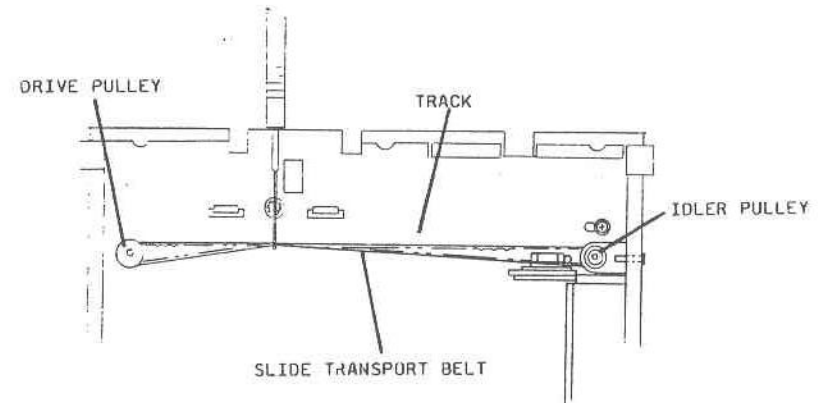
[9] Check that the following adjustment is correct:

Adjustment
SLIDE TRANSPORT BELT - Tension

Purpose: To obtain the correct tension for the SLIDE TRANSPORT BELT. If the tension is not correct, the SLIDE TRANSPORT CLIP will not engage the slides correctly. If the SLIDE TRANSPORT BELT is too tight, damage could occur to the SLIDE TRANSPORT MOTOR, the SLIDE TRANSPORT BELT, or the PULLEYS. If the SLIDE TRANSPORT BELT is too loose, the PULLEYS will not engage the SLIDE TRANSPORT BELT correctly, and slide transport errors could result.

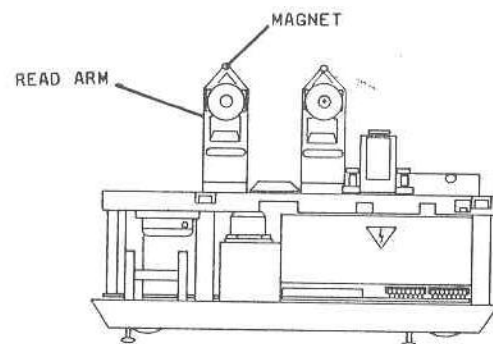
- [10] Check that the MAGNET is set in the READ ARM. Install a new READ ARM AND HEATER ASSEMBLY 351678 if necessary.

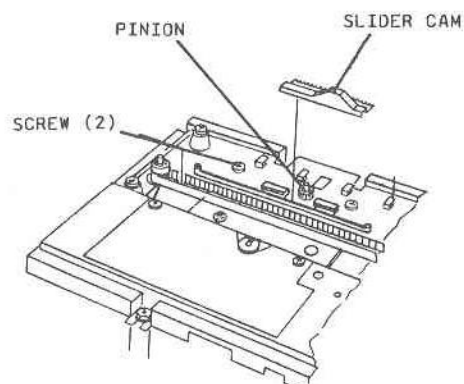
- [14] Enter options 110 and 111 and check that the SLIDER CAM lifts the ARMS to the correct height.

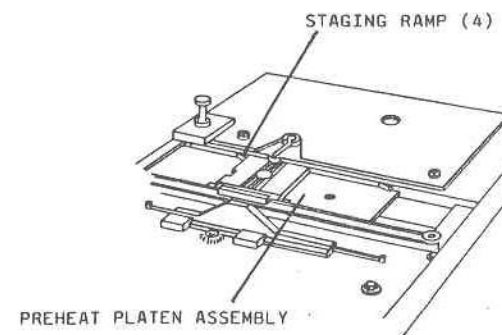
- [15] Do the following procedure to check that the slide seats correctly at the STAGING RAMPS:

- Enter option 70 to cancel the monitoring functions for COVER and temperature.
- Lift the OPERATOR ACCESS COVER about 30° to observe operation.
- Insert a slide at the Pickup Station.
- Enter option 108.
- Press "enter" and observe the motion of the slide.
- Continue to press "enter" and check that the slide seats correctly at the 4 STAGING RAMPS.
- If the STAGING RAMPS have damage, install a new PIPETTE LOCATOR 351567 or PREHEAT PLATEN ASSEMBLY 351566.

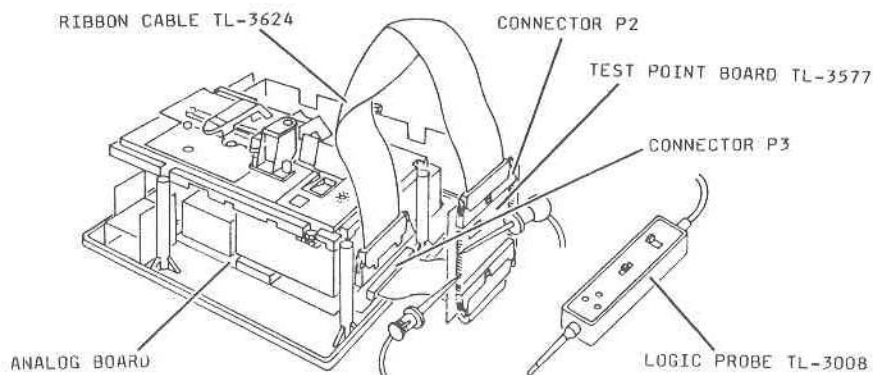
[6] Do the following procedure to check the drive signals from the CONTROLLER BOARD:

- Connect the RIBBON CABLE TL-3624 to CONNECTOR P2 on the TEST POINT BOARD TL-3577. Bend the RIBBON CABLE. See the figure.
- Connect the other end of the RIBBON CABLE to CONNECTOR P3 from the CONTROLLER BOARD.
- To obtain power for the LOGIC PROBE TL-3008, connect it to the TEST POINT BOARD TL-3577:
 - Connect the black wire to PIN 15 for ground
 - Connect the other wire to PIN 17 for power

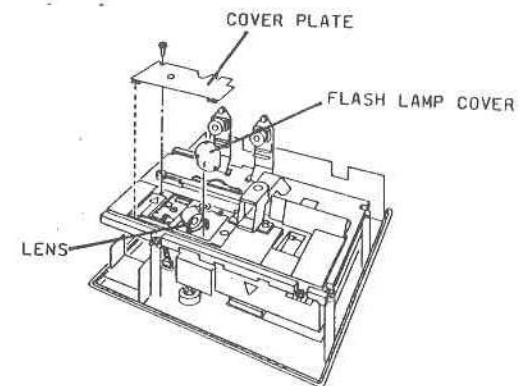
- [6] If necessary, clean the LENS with a dry swab.

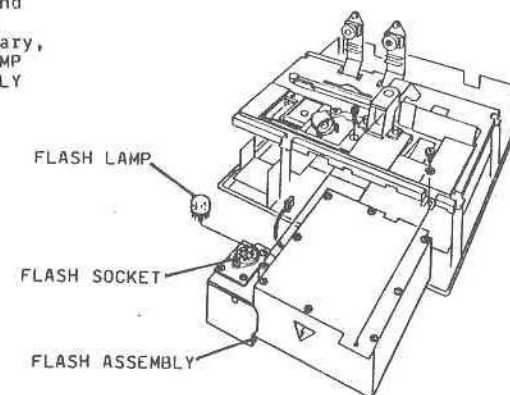
- [7] Check the FLASH LAMP and FLASH SOCKET for brown heat marks. If necessary, install a new FLASH LAMP 337379 or FLASH ASSEMBLY 351571.

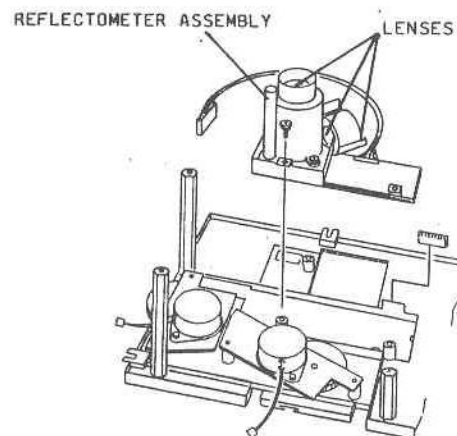
- [8] Clean the LENSES in the REFLECTOMETER ASSEMBLY with a dry swab. Use alcohol or warm water only if necessary.

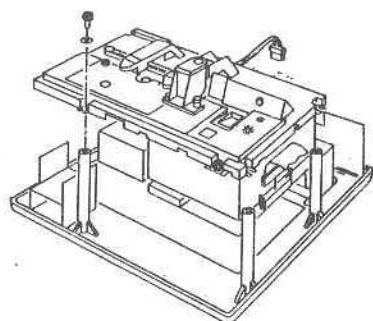
- [2] Do the following to remove
the FILTER WHEEL ENCLOSURE
ASSEMBLY:

- Remove the 4 SCREWS.
- Disconnect CONNECTOR P4
from the ANALOG BOARD.
- Remove the FILTER WHEEL
ENCLOSURE ASSEMBLY.

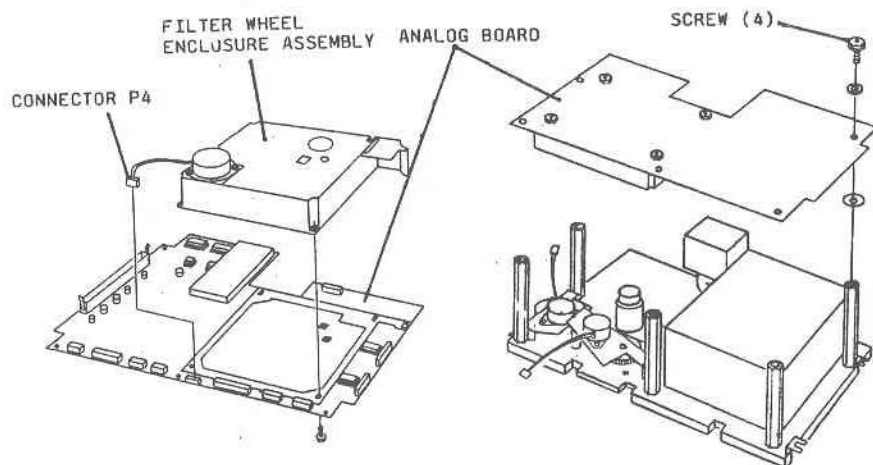
Filter

- [4] Check for dirty filters,
for filters that have
damage, and for empty
filter positions.

- [5] If necessary, clean the
filters with a dry swab.

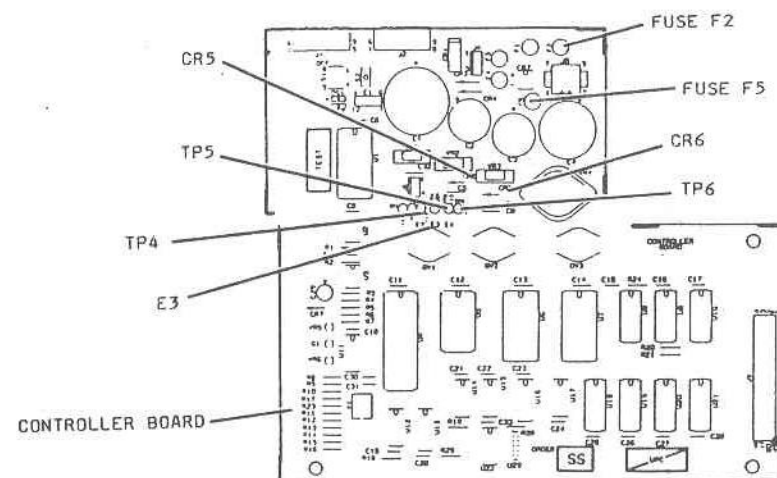
[5] Check for -15 V dc on the CONTROLLER BOARD:

MULTIMETER TL-3424			
Location	+	Ground	Voltage
CONTROLLER BOARD	TP6 or CR6,	TP4 or E3 cathode	-15 V dc

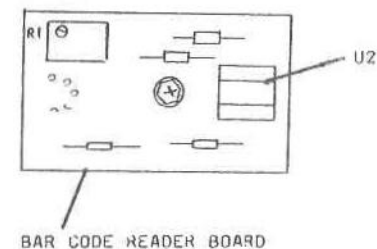
[10] Do the following adjustment:

Adjustment
BAR CODE READER - Voltage

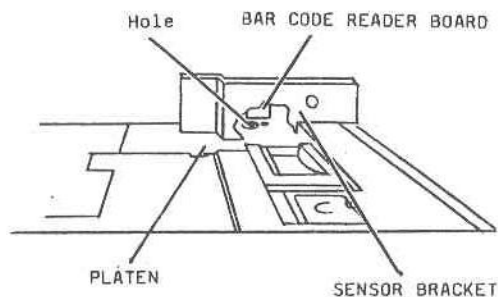
[14] Check that one of the red beams enters the hole in the PLATEN. If necessary, move the SENSOR BRACKET to align the beam with the hole.

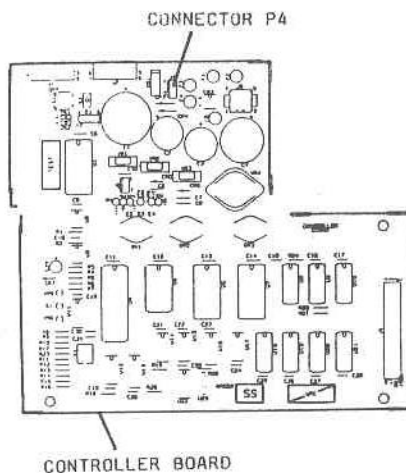
- [4] Seat CONNECTOR P4 on
CONNECTOR J4 of the
CONTROLLER BOARD.

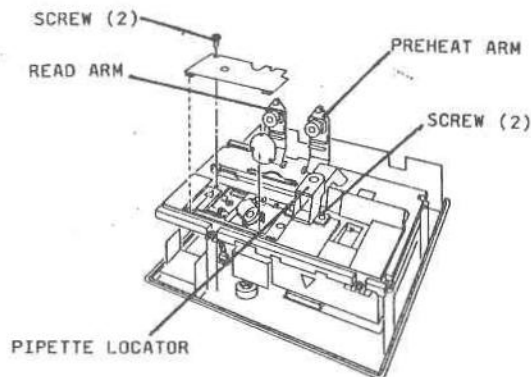
[1] Do the following procedure to check that the READ ARM or PREHEAT ARM are in the correct position:

- Check that the 2 SCREWS are holding the COVER PLATE fully down.
- Check that the SCREWS holding the PIPETTE LOCATOR are tight.

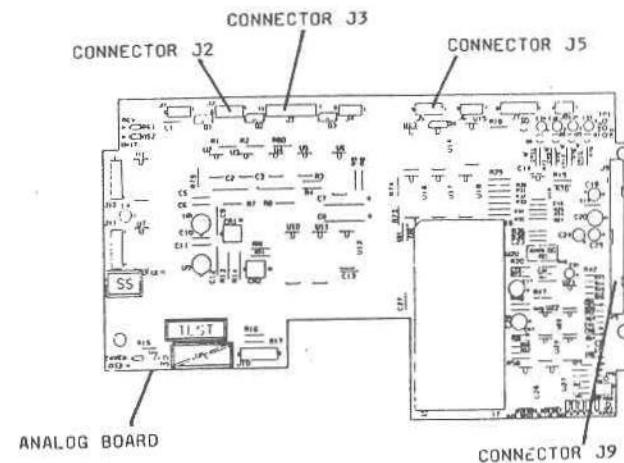
[3] Seat the following CONNECTORS on the ANALOG BOARD:

- CONNECTOR J2, for the READ ARM HEATER AND THERMISTOR
- CONNECTOR J3, for the PREHEAT PLATEN ASSEMBLY
- CONNECTOR J5 is for the PREHEAT ARM AND HEATER ASSEMBLY
- CONNECTOR J9, for the RIBBON CABLE ASSEMBLY to the CONTROLLER BOARD.

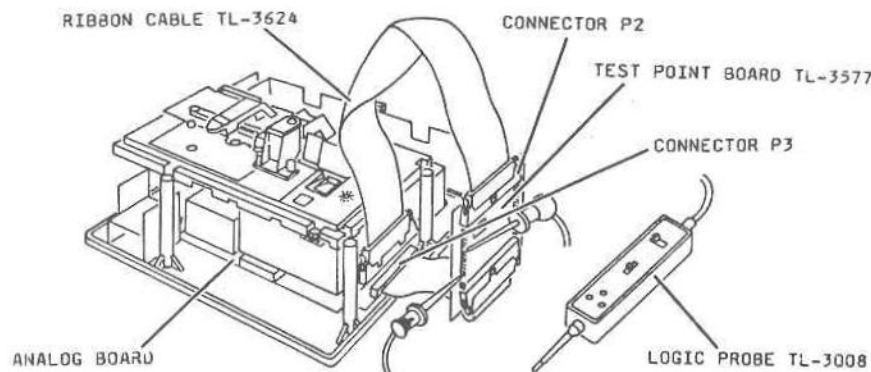
[13] Do the following procedure to check that the signals from the CONTROLLER BOARD are correct:

- Connect the RIBBON CABLE TL-3624 to the TEST POINT BOARD TL-3577. Bend the RIBBON CABLE. See the figure.
- Connect the other end of the RIBBON CABLE to CONNECTOR P3 from the CONTROLLER BOARD.
- To obtain power for the LOGIC PROBE TL-3008, connect it to the TEST POINT BOARD TL-3577:
 - Connect the black wire to PIN 15 for ground
 - Connect the other wire to PIN 17 for power

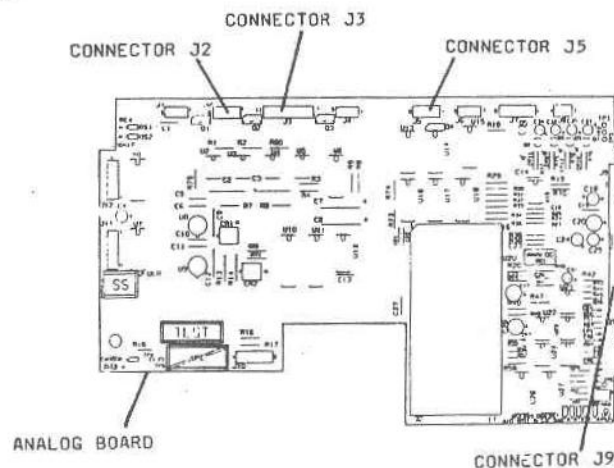
[11] Seat the following CONNECTORS on the ANALOG BOARD:

- CONNECTOR J2, for the READ ARM HEATER AND THERMISTOR
- CONNECTOR J3, for the PREHEAT PLATEN ASSEMBLY
- CONNECTOR J5 is for the PREHEAT ARM AND HEATER ASSEMBLY
- CONNECTOR J9, for the RIBBON CABLE ASSEMBLY to the CONTROLLER BOARD.

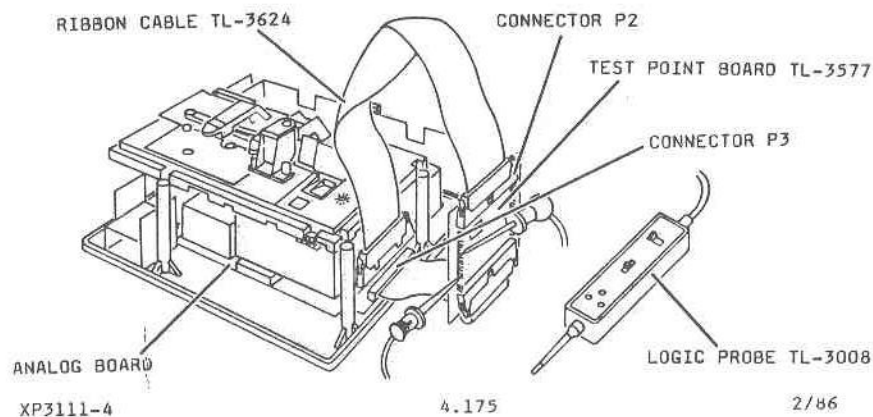
[20] Do the following procedure to check that the signals from the CONTROLLER BOARD are correct:

- Connect the RIBBON CABLE TL-3624 to the TEST POINT BOARD TL-3577. Bend the RIBBON CABLE. See the figure.
- Connect the other end of the RIBBON CABLE to CONNECTOR P3 from the CONTROLLER BOARD.
- To obtain power for the LOGIC PROBE TL-3008, connect it to the TEST POINT BOARD TL-3577:
 - Connect the black wire to PIN 15 for ground
 - Connect the other wire to PIN 17 for power

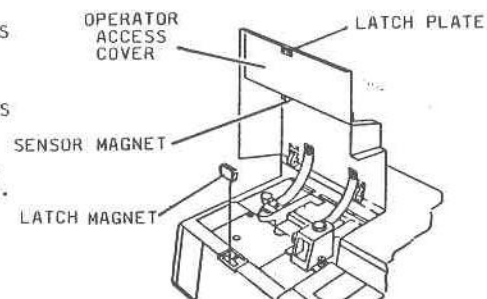
- [1] Check that the OPERATOR ACCESS COVER closes and seats correctly.
- [2] Check that the OPERATOR ACCESS COVER has a LATCH PLATE.
- [3] Check that the LATCH PLATE is aligned with the LATCH MAGNET.
- [4] Check that the SENSOR MAGNET is installed. Install a new OPERATOR ACCESS COVER if necessary.
- [5] Check that CONNECTOR P10 for the HALL EFFECT BOARD is seated on the ANALOG BOARD.
- [6] Check that the 2 SCREWS that hold the COVER are tight.

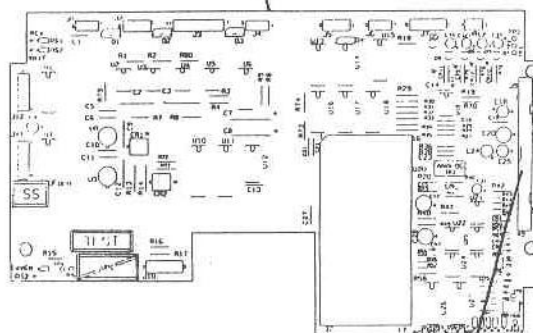
ANALOG BOARD

[9] Do the following procedure to check the signals from the HALL EFFECT BOARD:

- Remove the COVER.
- Connect the RIBBON CABLE TL-3624 to CONNECTOR P2 on the TEST POINT BOARD TL-3577.
- Connect the other end of the RIBBON CABLE to CONNECTOR J9 on the ANALOG BOARD.

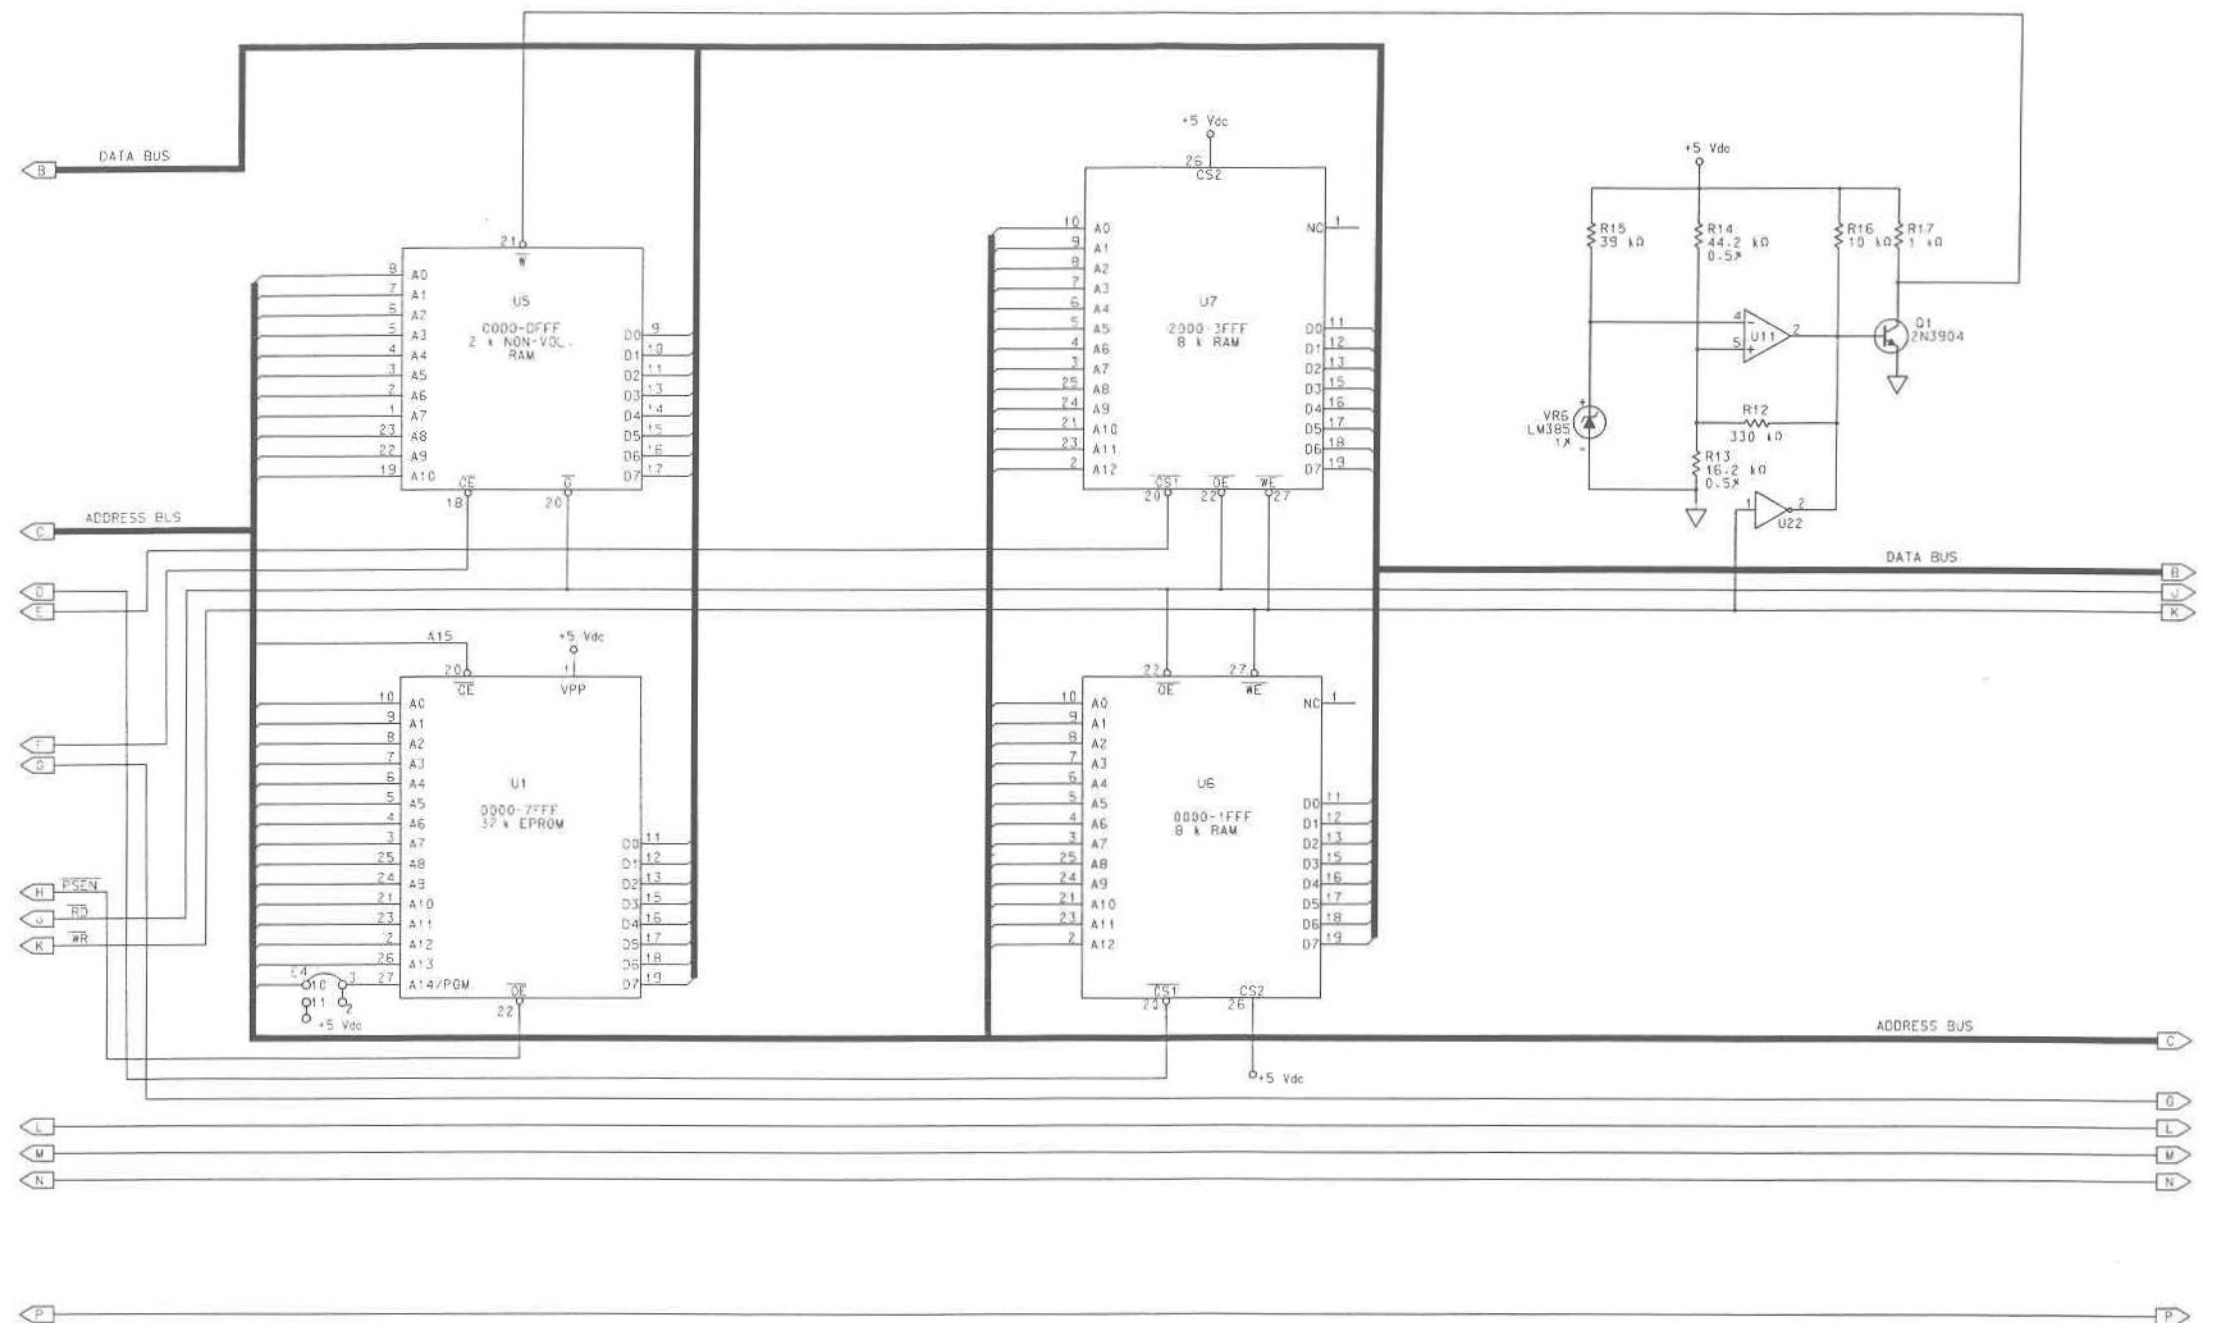
Figure 6b CONTROLLER BOARD

(Sheet 2 of 4)
